# PROPERTY INSPECTION REPORT

April 20<sup>th</sup> 2023

Inspected by Drz National Home Inspector llc / Lic#HI0093

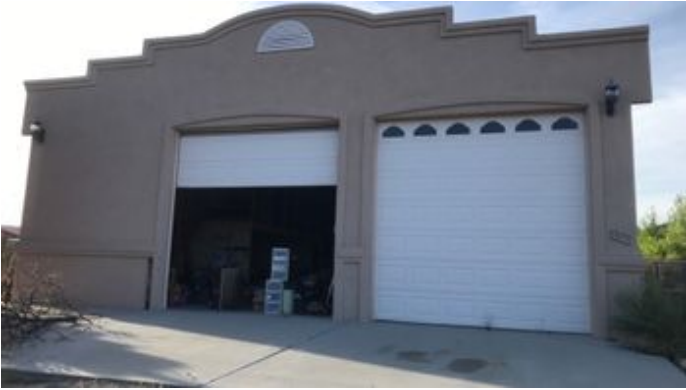
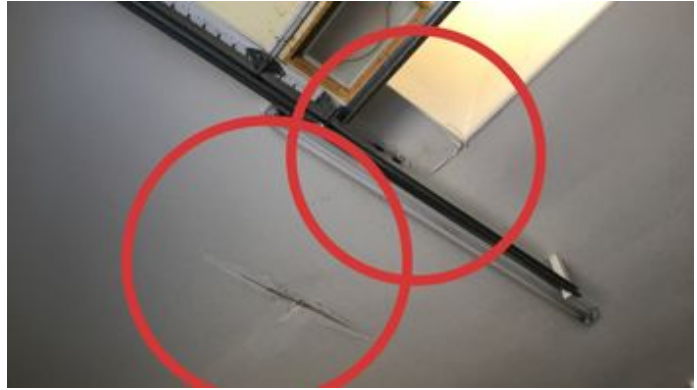
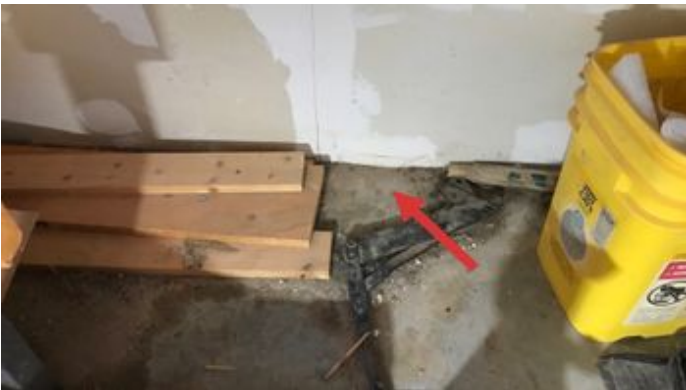
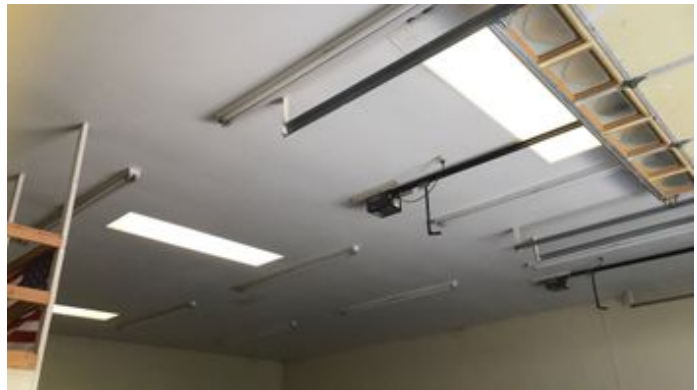
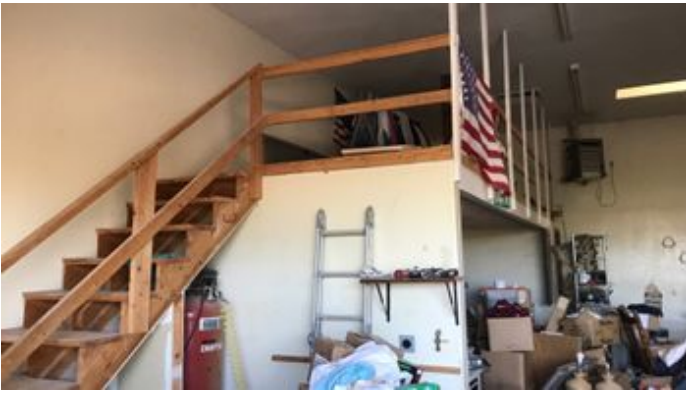
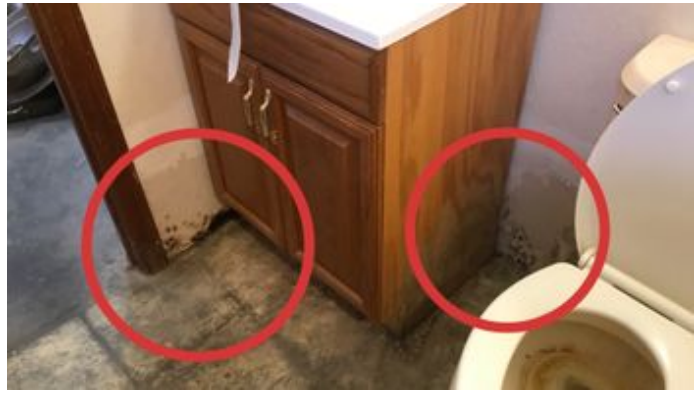
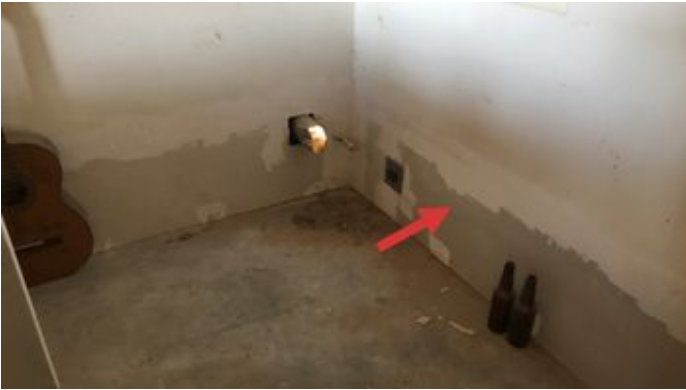
### 1.1 · STORAGE BUILDING

Storage building had one multiple areas with moisture damage / intrusion and a mold like substance, lights that were not operational, signs of past flood damage, substandard electrical installation at panel, stairs missing safety features. This list is not inclusive. For these repairs I would recommend a licensed professional contractor.

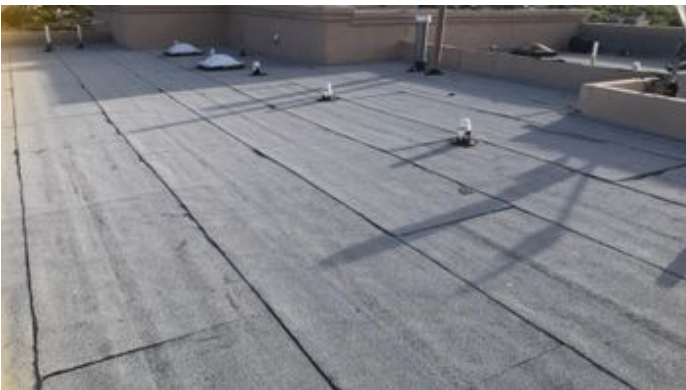
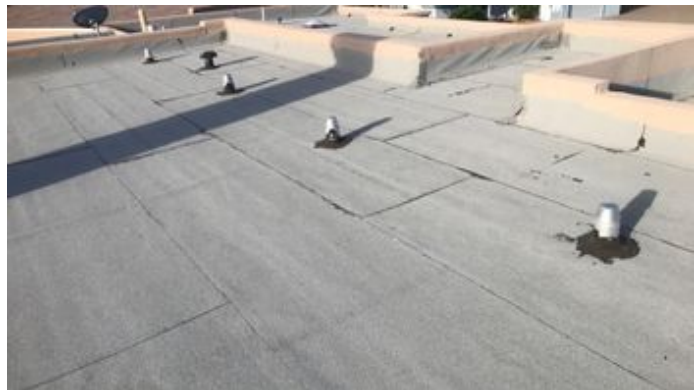
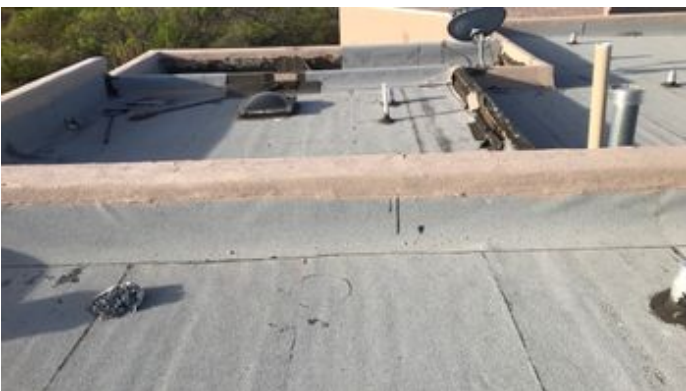
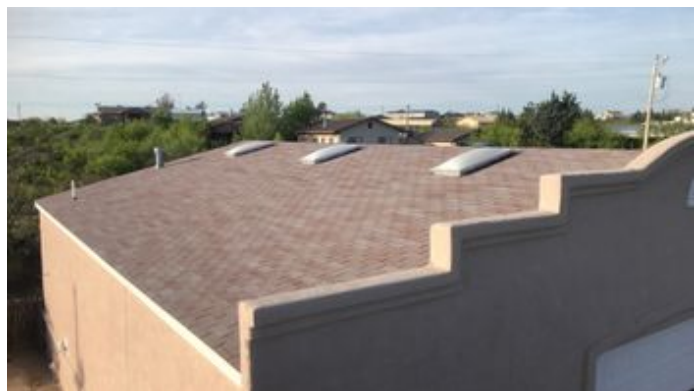
### 2.1 · MATERIAL

Modified bitumen roof, clay tile and asphalt shingles

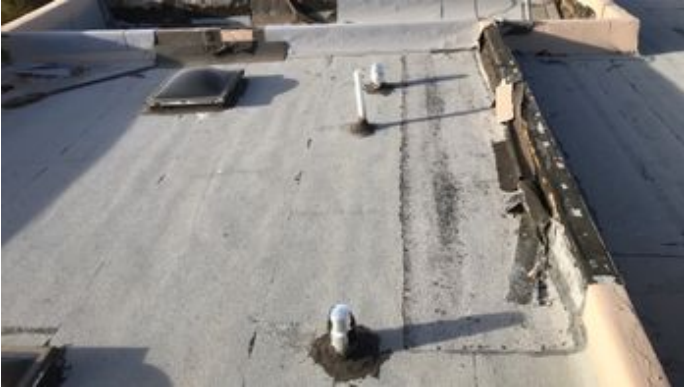
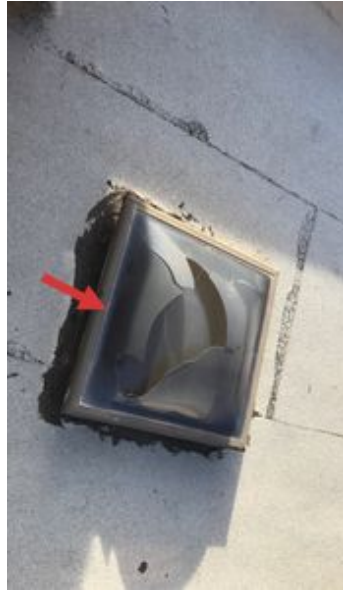
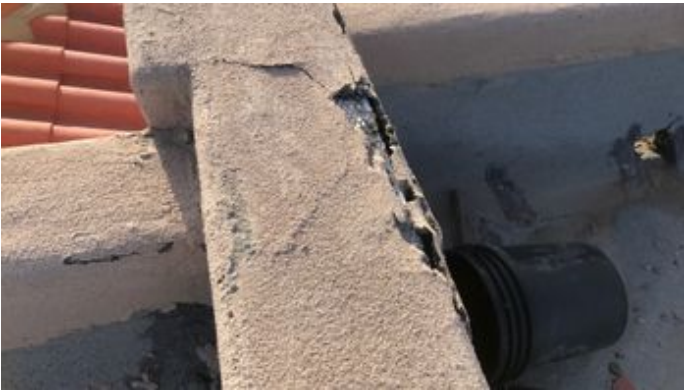
## 2.2 · DAMAGED (GENERAL)

Roof coverings showed multiple areas with damage. Recommend a professional roofing contractor evaluate the roofs and all there components. There was areas inside the homes with moister stains, lifted material, open seals, cracked parapets, improperly installed patches, missing roof material. This list is not inclusive.

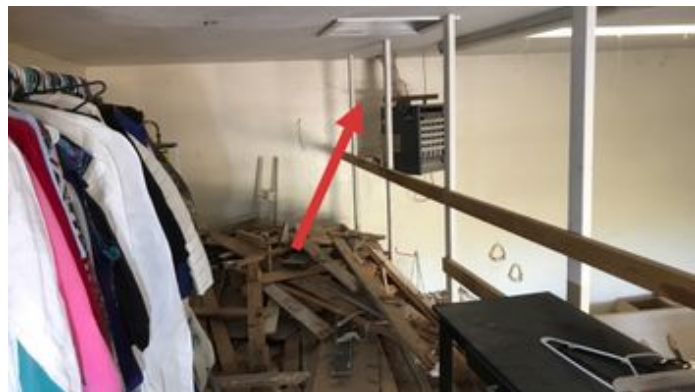
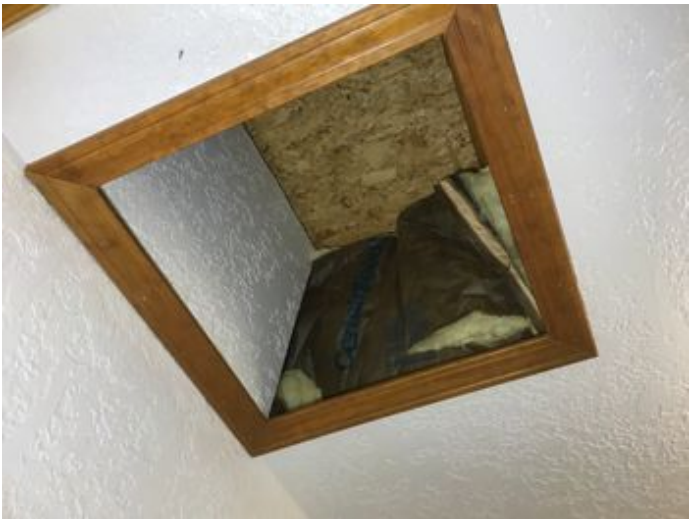
3.1 · ACCES DOOR

For safety reasons attic was not traversed. This is a flat roof and the crawl space has a limited access. Attic in garage area was blocked by debris and trash. Because garage and main home had signs of past or present leaks it's recommended to have these areas further reviewed by a professional contractor

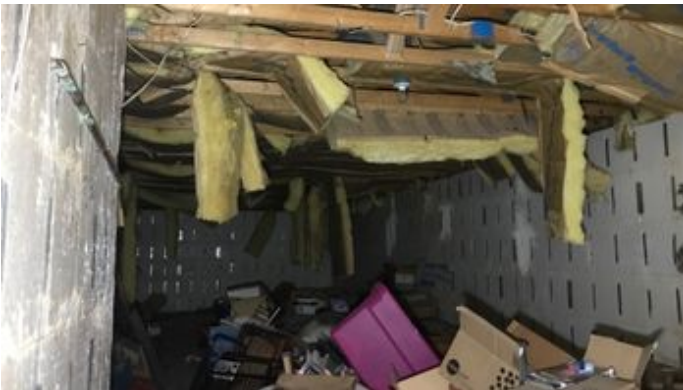
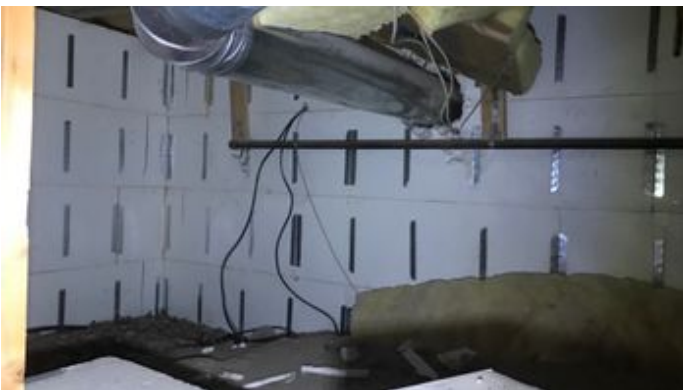
### 4.1 · GENERAL

Here is a general view of the crawl space underneath the home. During the inspection there were foul odors (the crawl space had a lot of animal feces) the vapor barrier appeared to be torn in places. Areas with signs of moisture damage. Damaged sub sheathing, The home appeared to be placed on support walls. Trusses were used for floor structure. I recommend you have a professional contractor further review for repairs

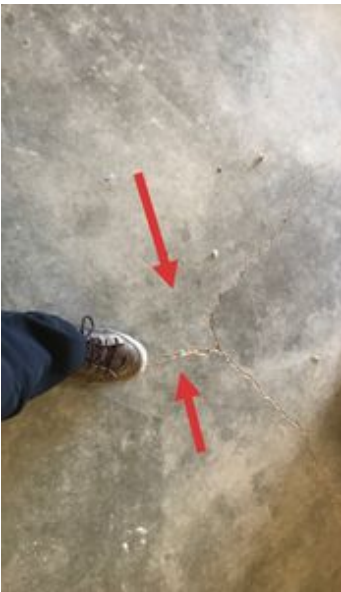
### 4.2 · FOUNDATION CRACKS

Foundation cracking / shifting was noted on the interior floor of additional garage. Recommending further review and repair by a professional concrete contractor. Depending on his findings you may want to consult a licensed structural engineer for repair ideas.

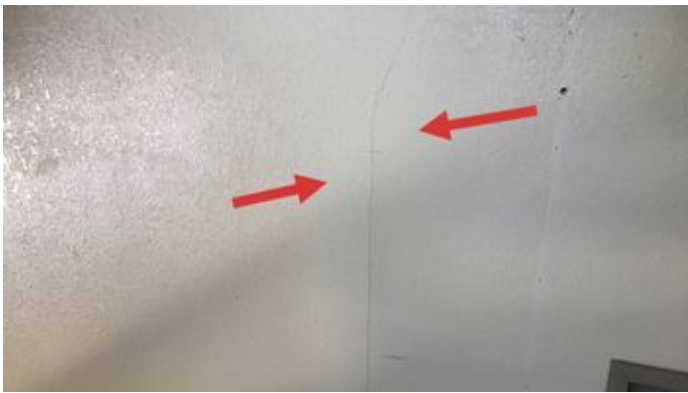
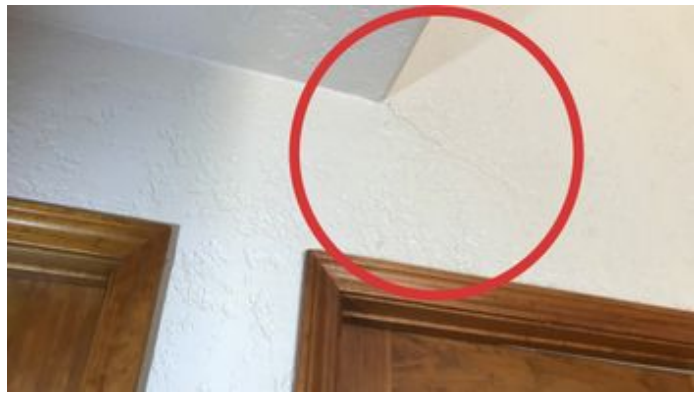
### 4.3 · CRACKS

Cracking observed in wall structure in garage and interior of the home. Settlement is normally associated with these cracks. Recommend a professional structural engineer evaluate and advise on repairs if any are needed.

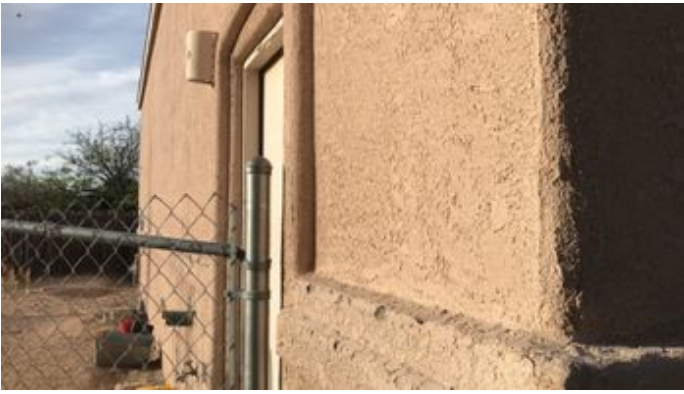
5.1 · SIDING MATERIAL

Stucco exterior finish. Maintenance tip When stucco is first applied to your home, it could be sealed. Some products can be a porous material, stucco needs to be protected from any moisture intrusion. Elastomeric is a common sealant used.

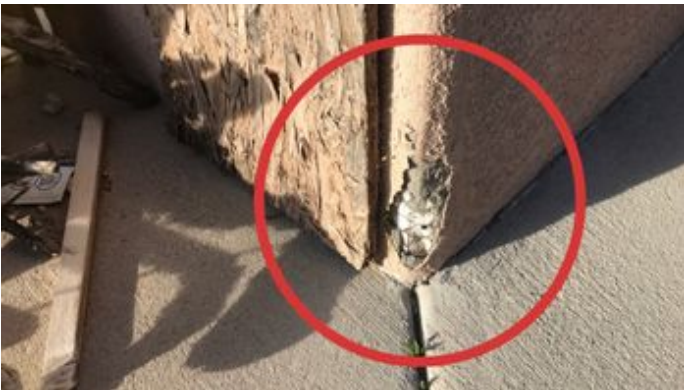
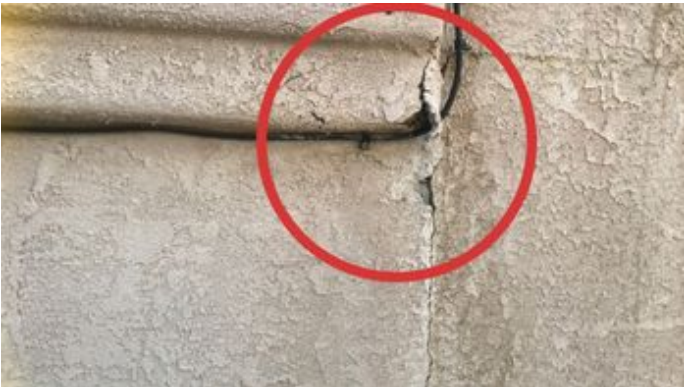
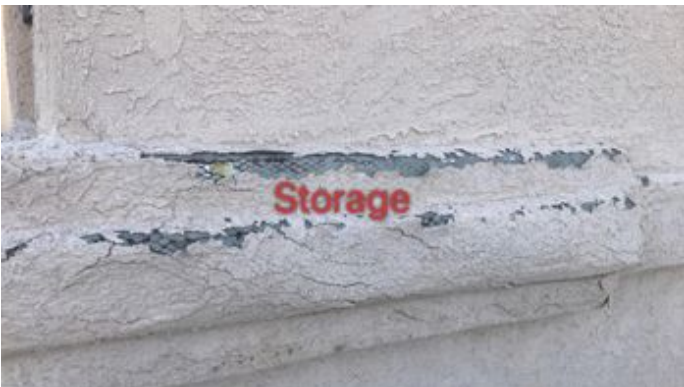
## 5.2 · WARPING/BUCKLING/ROTTING

Warping or buckling of stucco was noted during the inspection at multiple locations around the home/ garage addition. This could be caused by improper installation or moisture intrusion. I recommend you have a professional stucco contractor evaluate and repair.

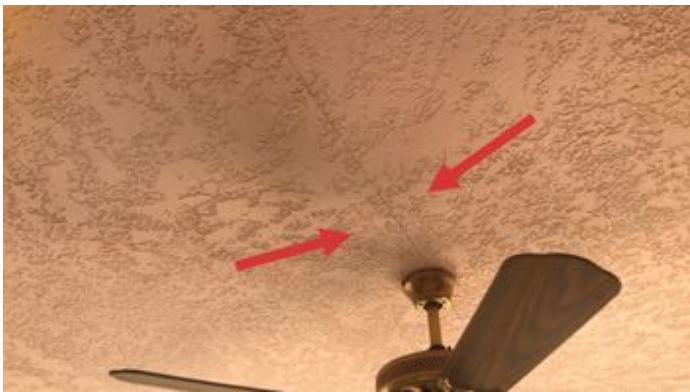
5.3 · PORCH CEILING

The back porch had cracking. This is often caused by seasonal changes expansion and contraction of the wood beams underneath can cause cracks on the surface of the sheet rock. Recommending repair by a professional Sheetrock contractor.

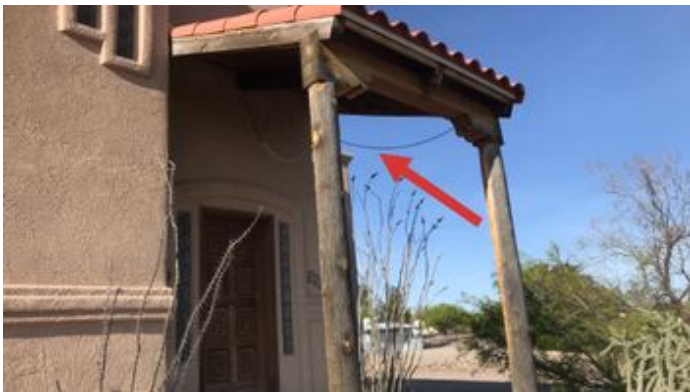
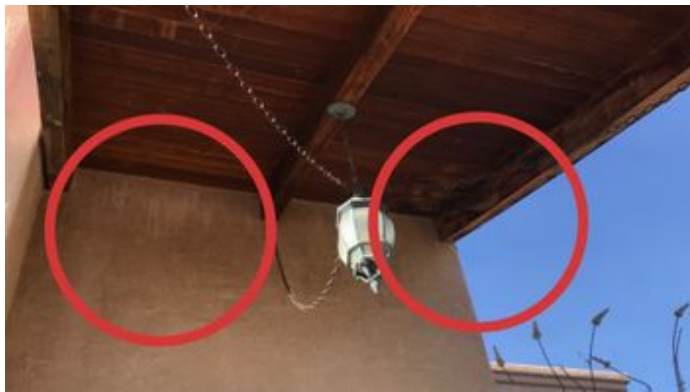
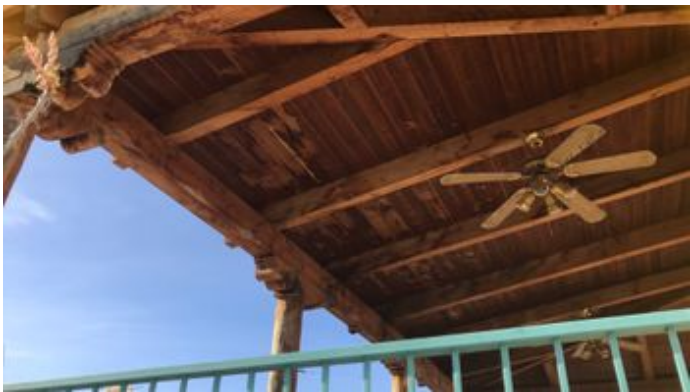
5.4 · POLES & BEAMS

Porch support beams were splitting, some sections were warping some areas had missing clips ties or sub standard framing. This is what wood does naturally when dried out. Back porch ceilings had signs of water damage. Recommending review and repair by a professional framing contractor

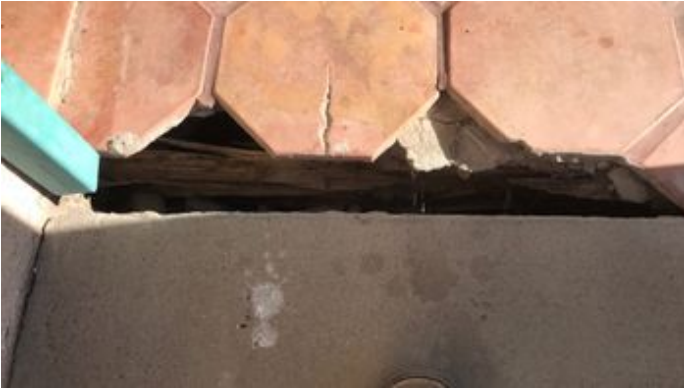
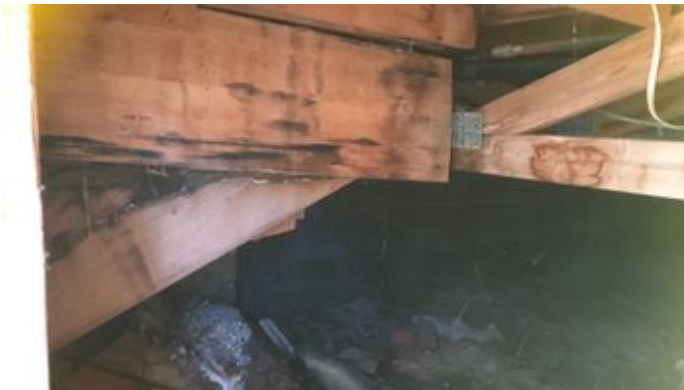
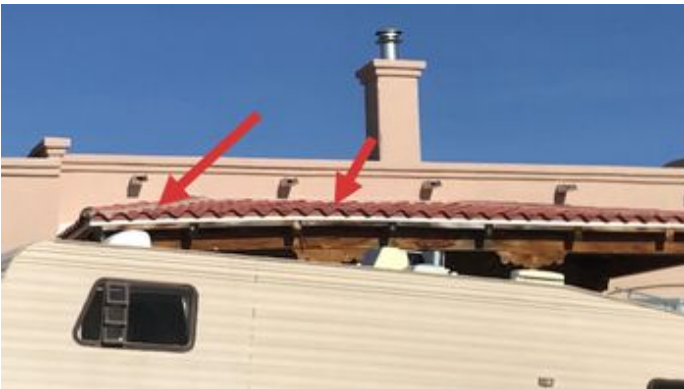
### 5.5 · DECKS / BALCONY

One or more areas of the deck support appears unsafe. It's appeared to be rotting in one section and the structure failing in this area. As a result support Columns are shifting. Recommend qualified framing contractor evaluate and repair.

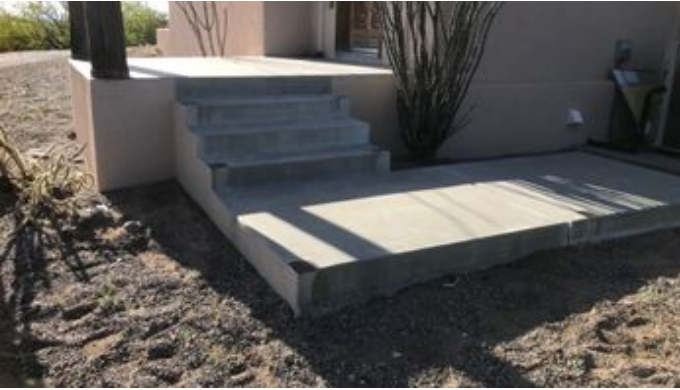
## 5.6 · STAIRS

One section of the exterior is missing safety features on stairs. This is a safety concern someone could accidentally fall. I recommend you have this looked at by a professional contractor. One other gate also opens toward stairs. This is not safe

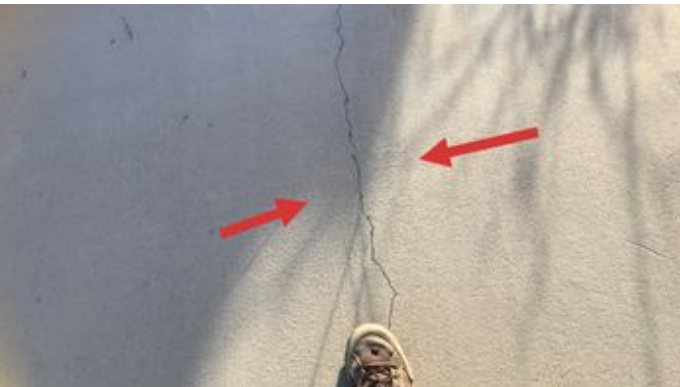
## 5.7 · DRIVEWAY CRACKING

Cracks observed in drive way. This can be common especially since this is we're heavy vehicles come in and out. Recommend concrete contractor evaluate and repair. Located at garage addition and main home

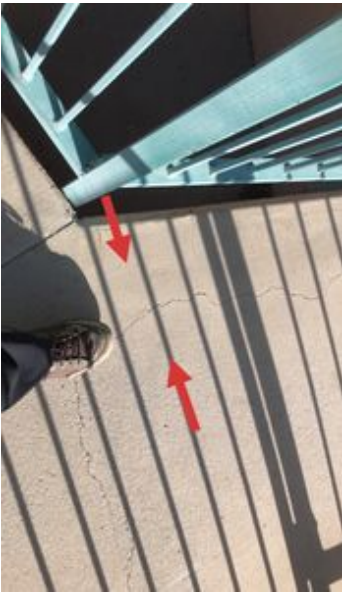
## 5.8 · WALKWAY CRACKING

cracks observed on multiple walkways. Recommend monitor and/or patch/seal by a professional concrete contractor.

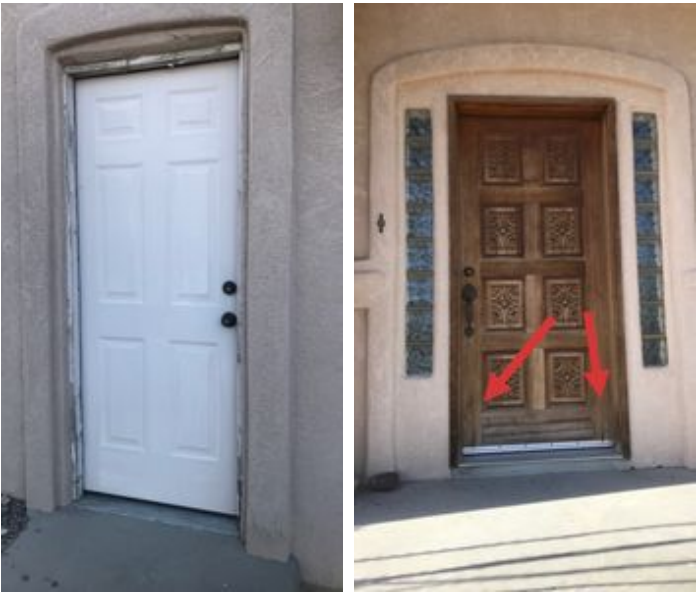
5.9 · EXTERIOR ENTRY DOOR

Exterior entry doors showed signs of damage. Rotted wood, doors rubbing on the jambs, latches not working properly. I recommend you have a professional door contractor repair.

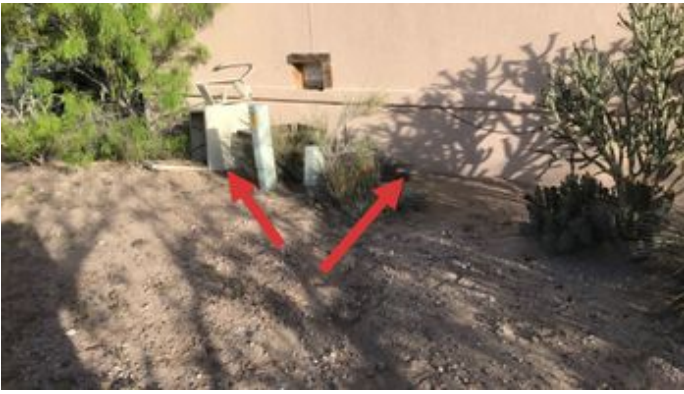
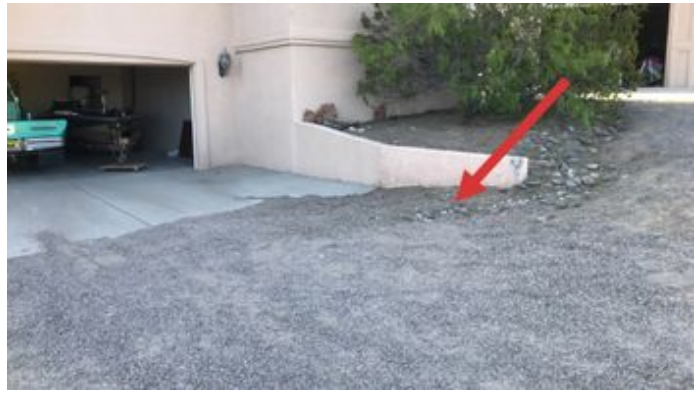
5.10 · GRADING

Grading is sloping towards the home in multiple areas. This could lead to water intrusion and foundation issues. It's recommended to have this repaired to prevent moisture intrusion. A professional landscaping contractor can give you ideas on grading so water flows away or around the home. Since the home is situated on a hill side it's also recommended to keep an eye on these areas to keep them from eroding

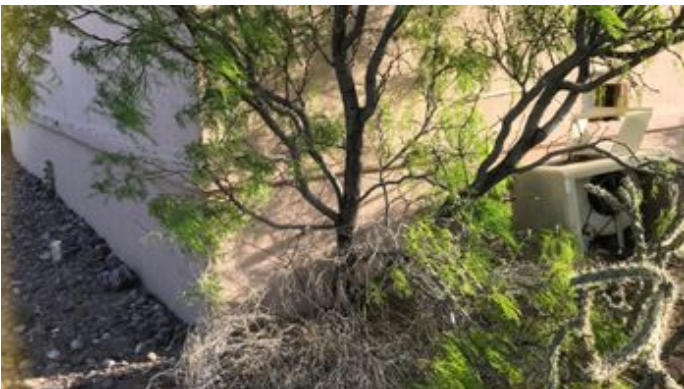
## 5.11 · TREE TO CLOSE TO THE HOME

Trees too close to the home. This could cause damage to the siding or allow wood destroying organisms to enter the home. The roots can also damage the foundation. Especially in the windy season. Recommend you have a landscaping service evaluate and repair.

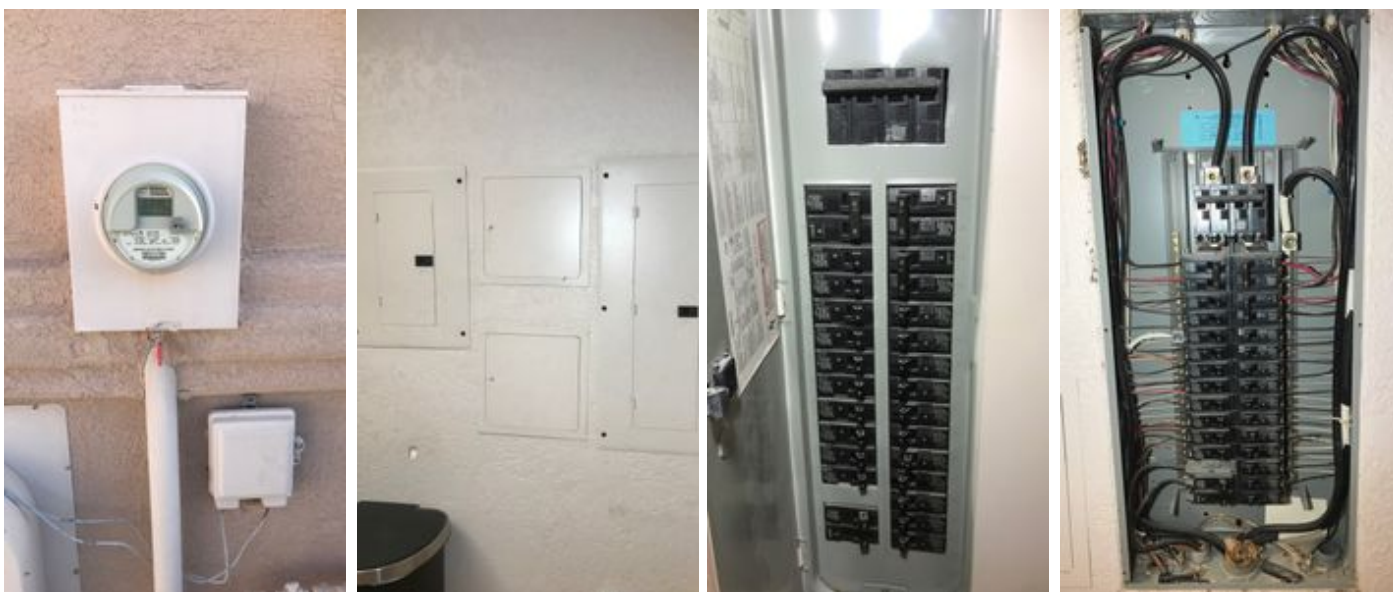
### 6.1 · PANEL MANUFACTURER

200 Amp Simeons panel.

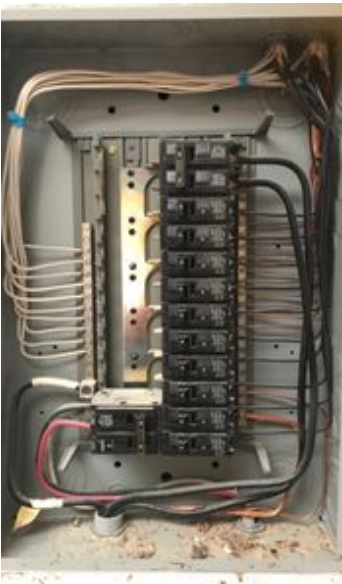
### 6.2 · SUB PANEL LOCATION

100 amp sub panel located at interior

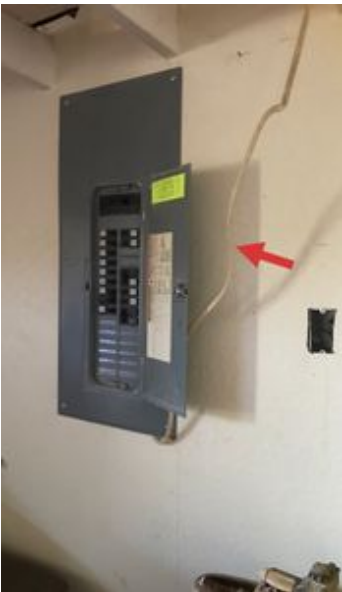
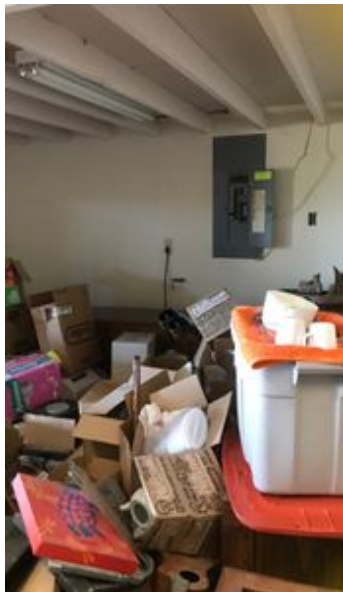
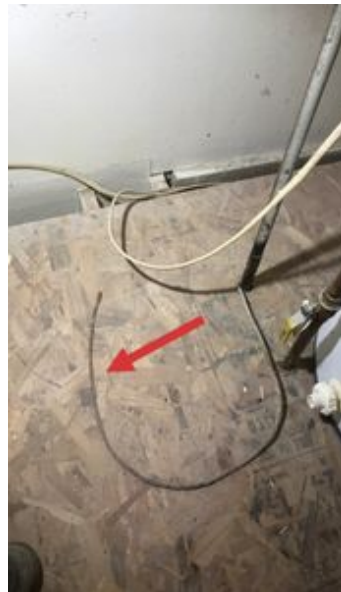
### 6.3 · SUB PANEL LOCATION

Sub panel located in garage. Recommending review by a licensed electrician. Inspector observed improperly installed conductors which is unsafe. The ground also appeared to be disconnected.

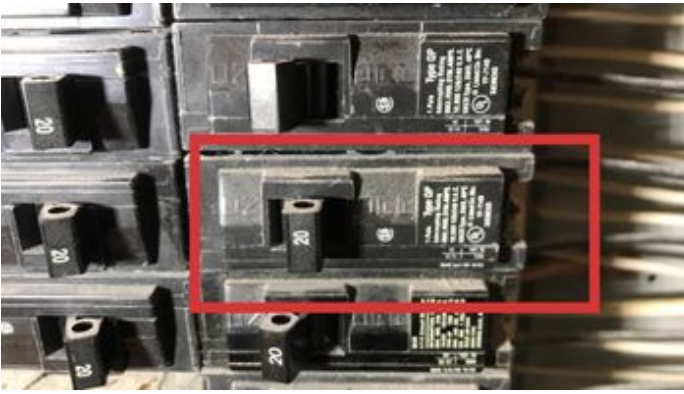
### 6.4 · BREAKERS

1 breaker switch was in the jumped position during the inspection. I recommend you have this breaker reviewed by a licensed electrician. Recommending further review by a licensed electrician.

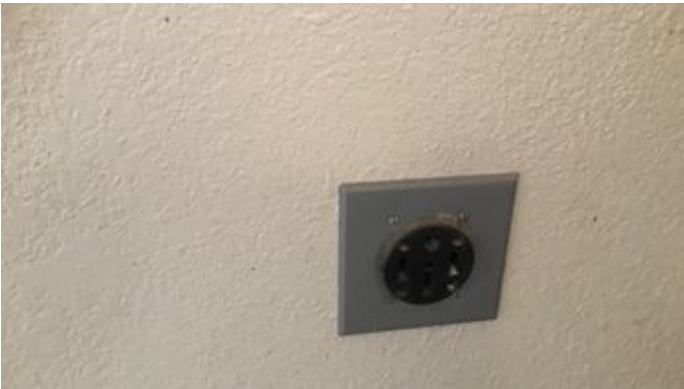
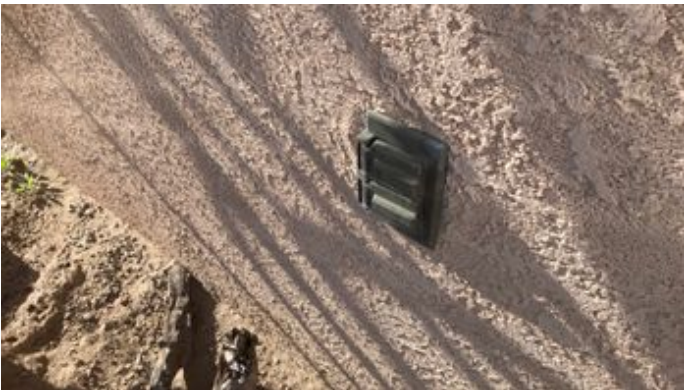
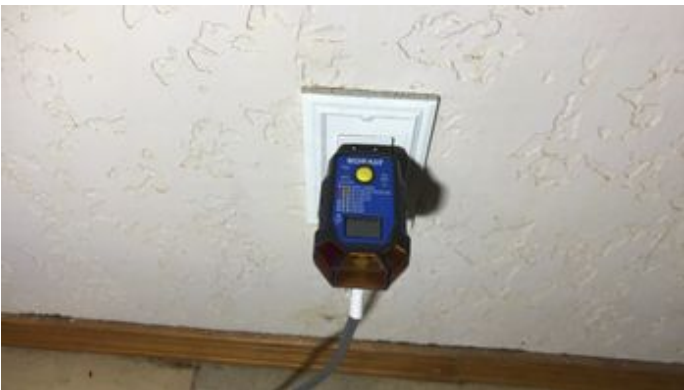
6.5 · RECEPTACLES

Multiple receptacles seemed to be operating incorrectly, some were broken, missing / damaged plates or loose outlets. Other areas had lights that were not operational, switches not operational, moisture intrusion through switch, improper wiring was also noted, improperly terminated electrical conductors. This list is not inclusive. I recommend you have electrical components further reviewed and repaired as needed by a licensed electrician.

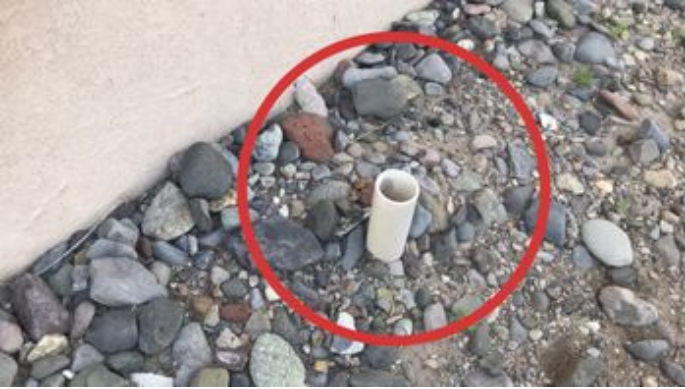
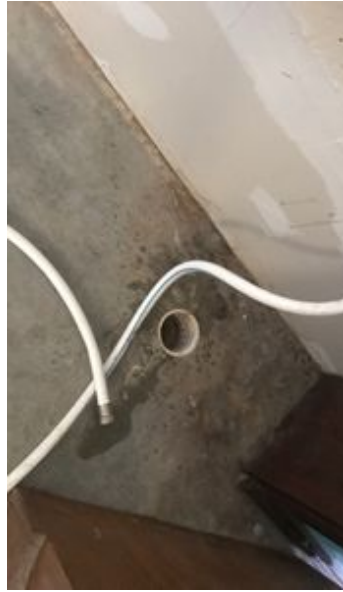
## 7.1 · CLEAN OUT CAP

Missing clean out cap. It's recommended to replace cap to keep debris from entering the pipes. Recommending repair by a licensed plumber. Located at Additional garage

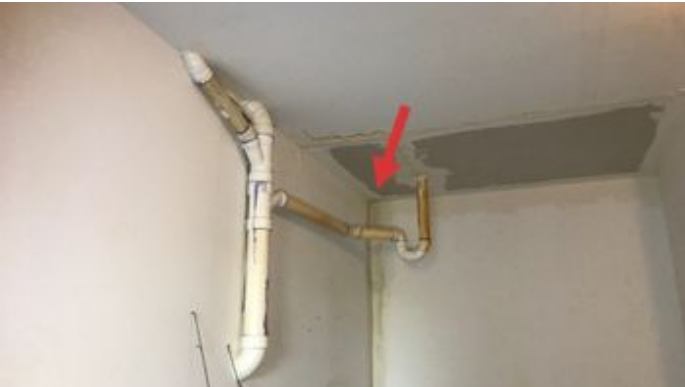
## 7.2 · DRAIN PIPE

Missing supports were noted on drain lines. Recommending review by a licensed plumber. Located at garage and basement

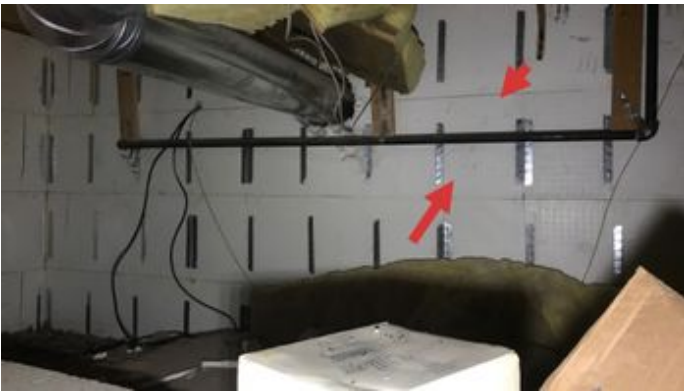
### 7.6 · GAS LINES

Gas lines are missing sufficient supports. Located at basement. These help stabilize the gas line and keep it from bending or breaking at joints and elbows. I recommend you have some clamps installed by a licensed plumber.

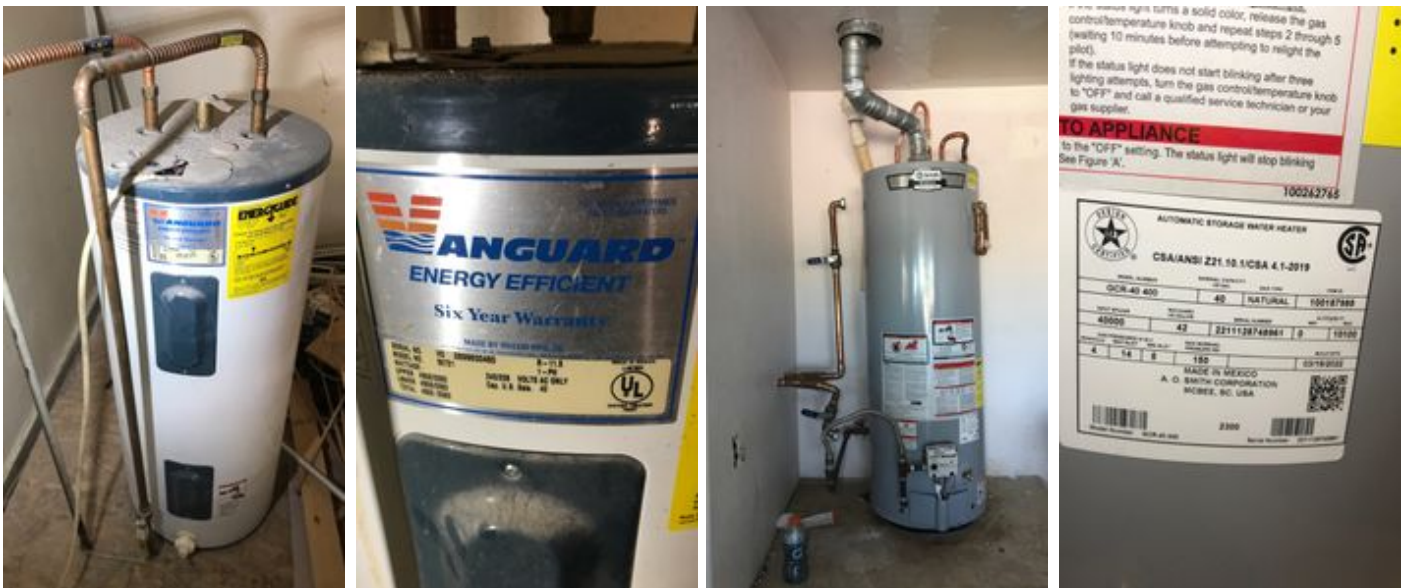
### 7.8 · MANUFACTURER

Two 40 Gal natural gas / Electric water heaters. Manufactured in 1999 & 2022. These typically have a life span of 12 years with good maintenance. Functional during the inspection.

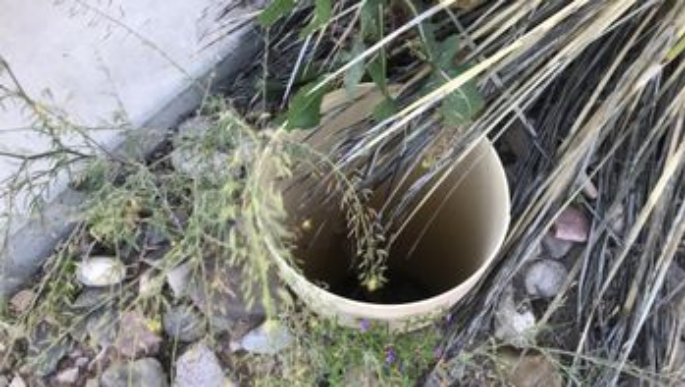
### 7.10 · VALVE BOX

Valve boxes were full of dirt. Typically these boxes house shut off valves for irrigation systems. They provide protection from the elements. I recommend you have them cleaned by a professional handyman or you can DIY.

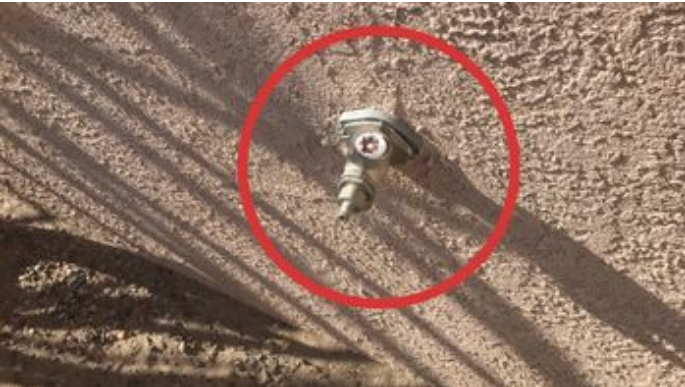
### 7.11 · EXTERIOR FAUCET

Exterior faucet missing handle. It's recommended to have this repaired by a licensed plumber.

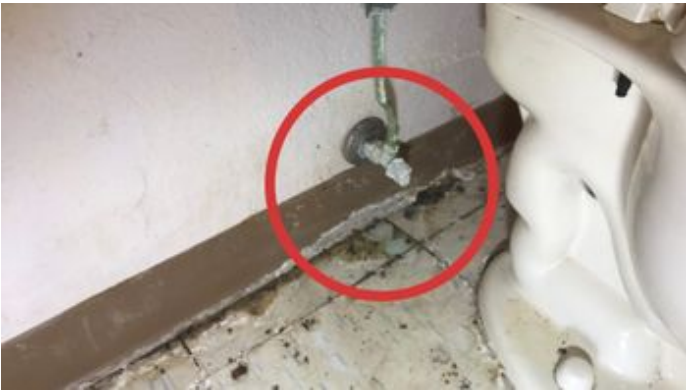
### 7.12 · SINK/TOILET

Leaking toilet valve. Located at garage bathroom in main home

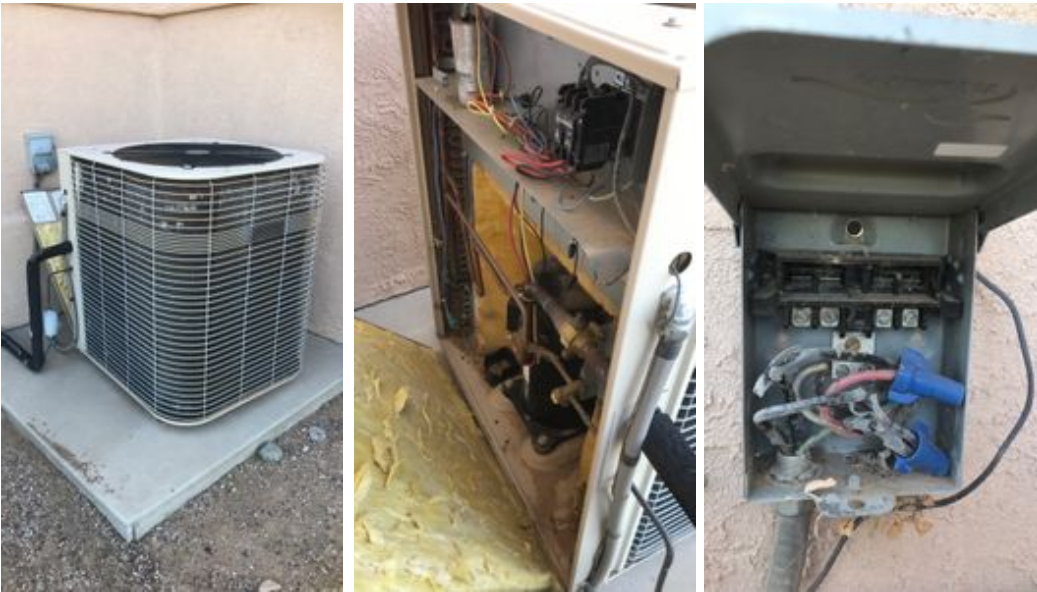
8.1 · BRAND

Condenser unit. Manufacture date unknown. These typically have a service life span between 8-20 years but can last longer with good maintenance. Not Functional during the inspection. Recommending further review by a licensed HVAC technician

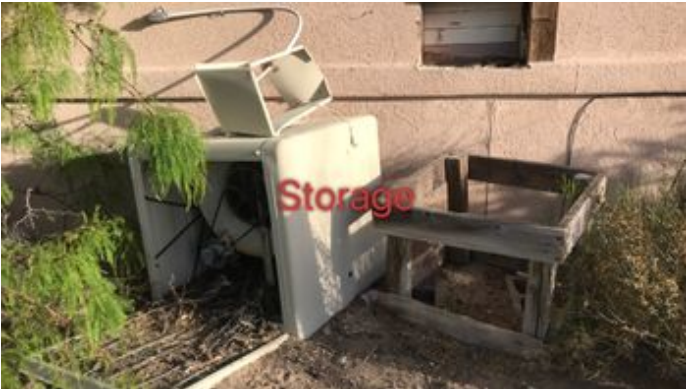
## 8.2 · ENERGY SOURCE/TYPE

Damaged swamp cooler located at additional garage. Recommending professional heating and cooling contractor repair. And have this hole in the wall properly sealed

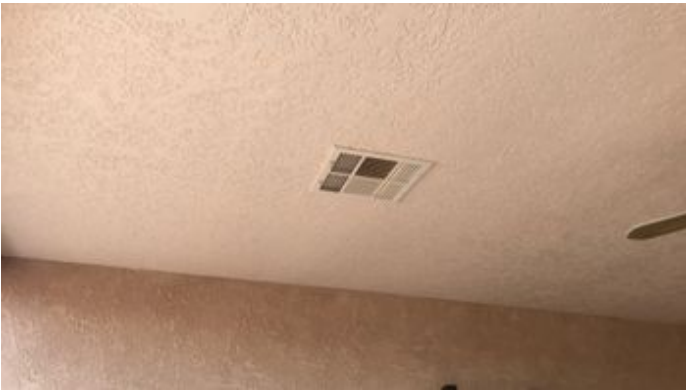
## 8.3 · REGISTERS

One register was located on exterior of the home. It's not clear why. This could lead to efficiency loss. Recommending further review by a licensed HVAC technician.

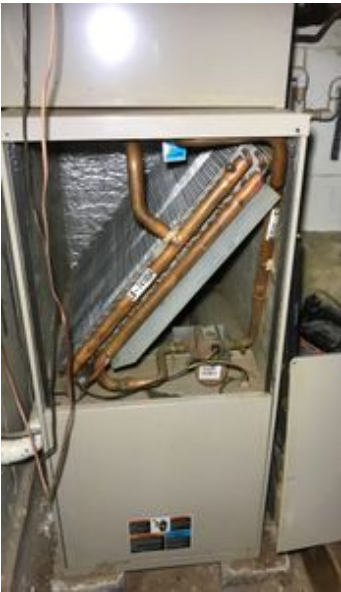
9.1 · BRAND

Forced air Water furnace system. This appears to be disconnected or possibly abandon. It was not operational during the inspection.

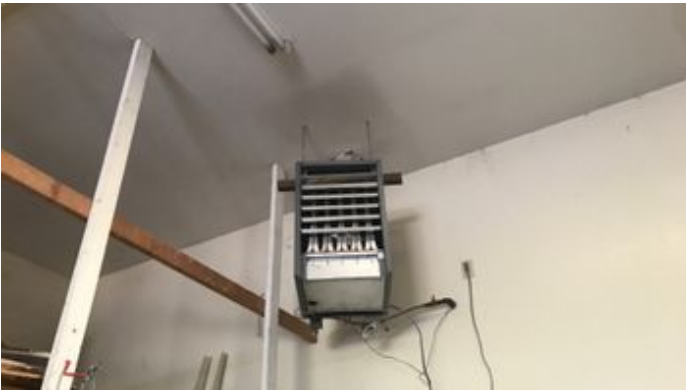
9.2 · BRAND

Heat exchanger located in additional garage. This unit appeared to be shut off and not operational using normal operating controls during The inspection. Recommending licensed HVAC technician further review.

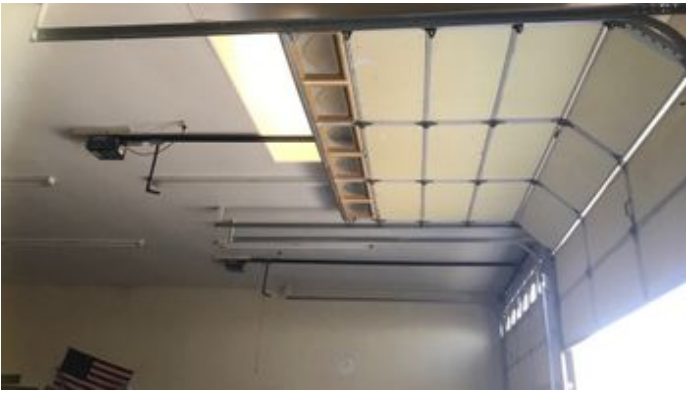
10.1 · GARAGE DOOR MECHANISM

Garage door does not function recommending you have this evaluated and repaired by a garage door contractor. Located at additional garage.

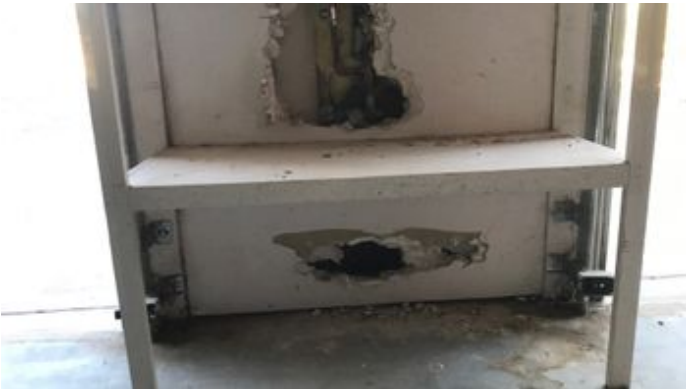
10.2 · DRYWALL

Garage walls had damaged drywall or open walls. Recommend professional drywall contractor repair. Located at home and additional garage

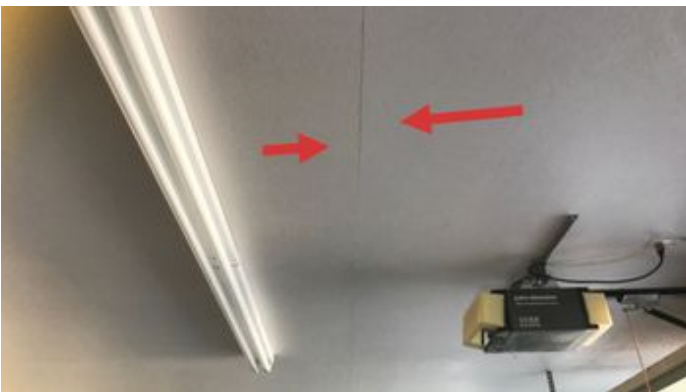
10.3 · CRACKING

Garage ceiling had long crack. With seasonal changes the trusses tend to expand and contract it could cause long cracks along the seems or joints of sheet rock. Recommending repair by a professional Sheetrock contractor.  
Located at main home and additional garage

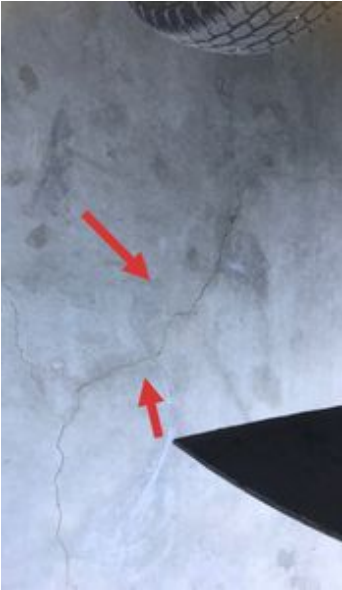
### 10.4 · CRACKING

cracks in the garage floor. This happens over time since the garage is where heavy vehicles drive in and out constantly. Suggesting evaluation by a concrete contractor.

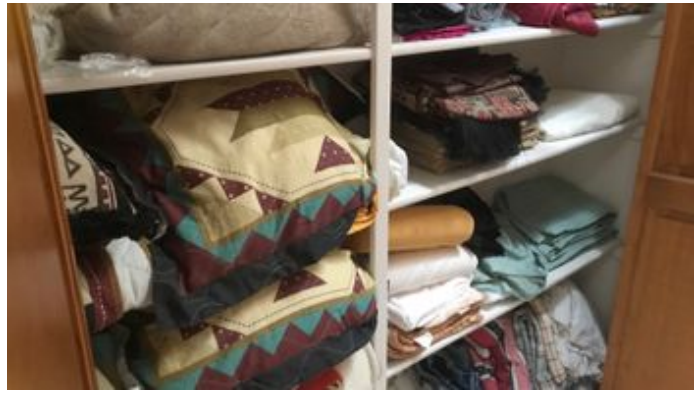
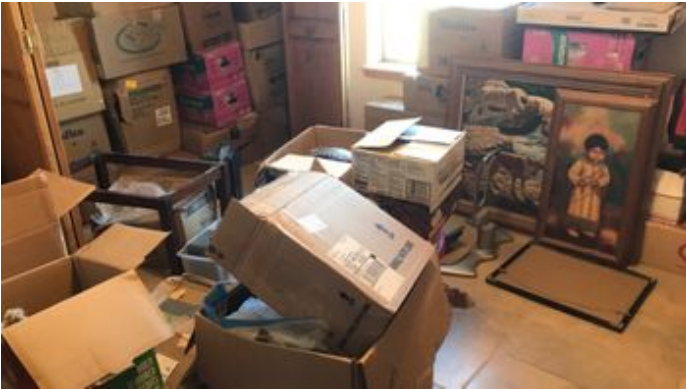
11.1 · OBSTRUCTION / UNFINISHED SPACES

Some areas of the home(s) had the current home owners belongings. This limited the view of the inspector in multiple locations. I was able to check a representative numbers of outlets, floors, walls and windows.
