# PROPERTY INSPECTION REPORT

April 20<sup>th</sup> 2023

Inspected by Drz National Home Inspector llc / Lic#HI0093

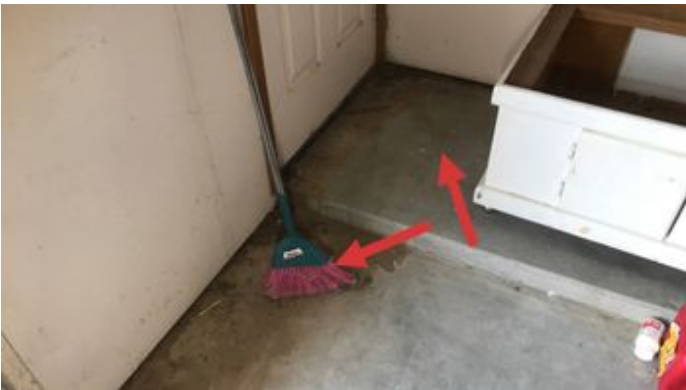
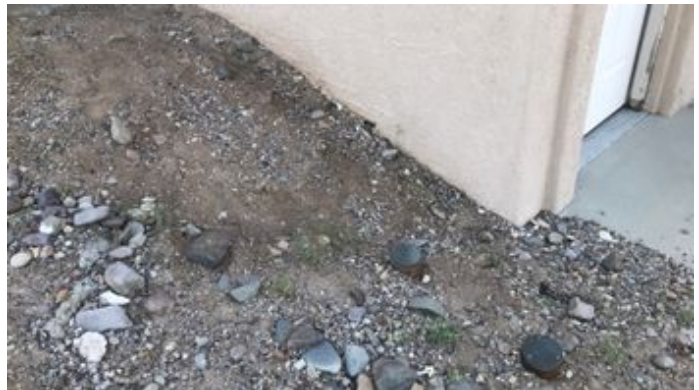
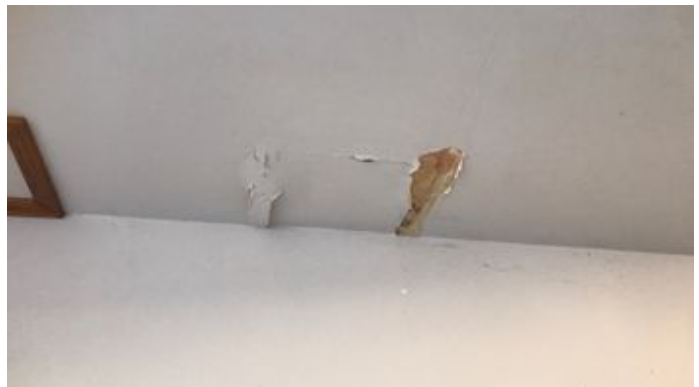
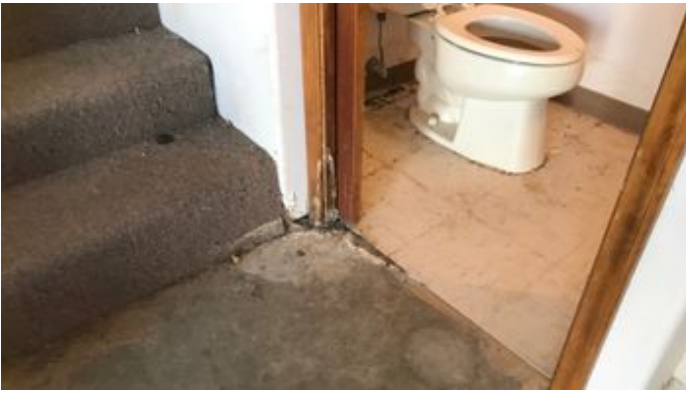
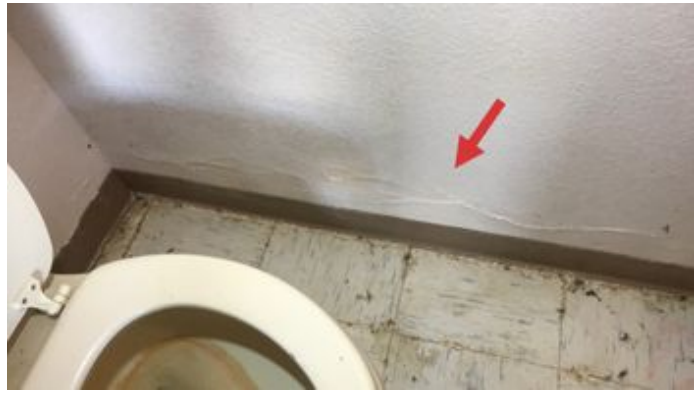
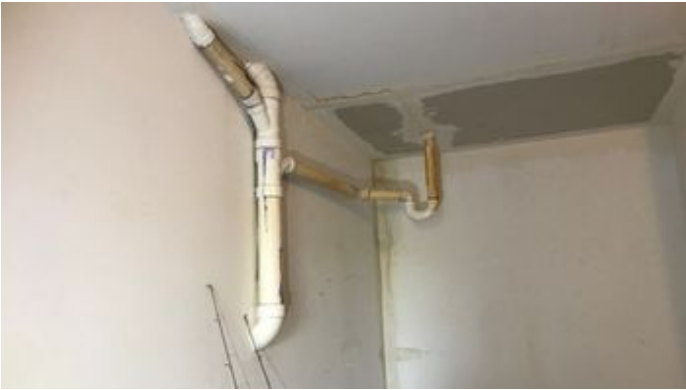
### 11.2 · MOISTURE DAMAGE

Moisture damage was located in multiple areas of home and additional garage. Possibly from past or present roof/plumbing leaks. Some of these areas had signs of mold growth. I recommend you have a professional contractor further review and repair.

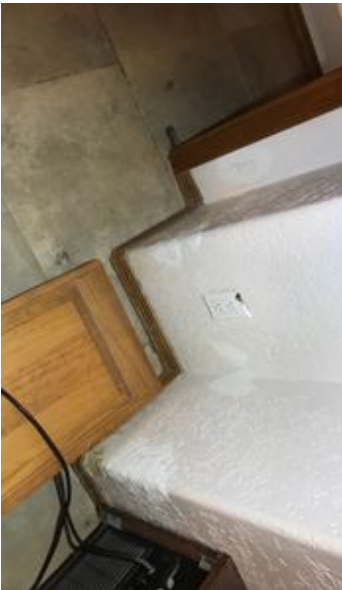
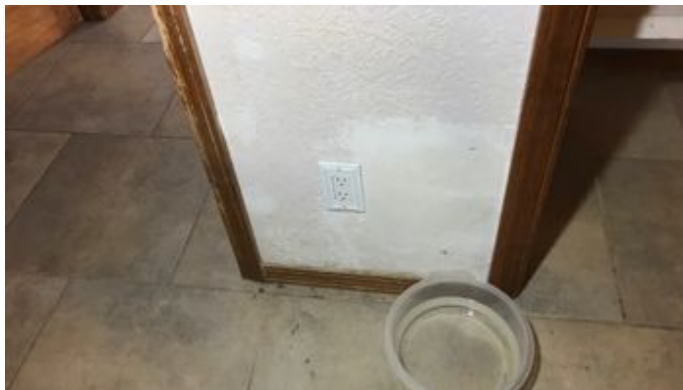
### 11.3 · ODOR

Inside of the home had a foul odor. Possibly from fecal matter from cats and dogs. There was also signs of roach infestation. Some areas had heavy urine stains and drywall damage from urine. Recommending review by a professional pest control / contractor and a cleaning company.

Recommending repair

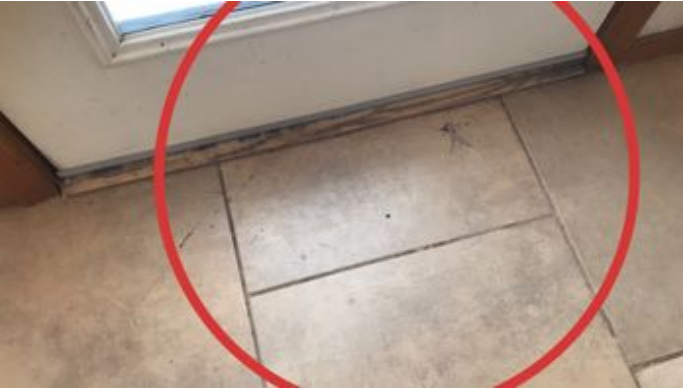
## 11.4 · DAMAGED (GENERAL)

Cracked/ chipped tiles Recommending evaluation & repair by a professional flooring contractor. Located at front entrance way.

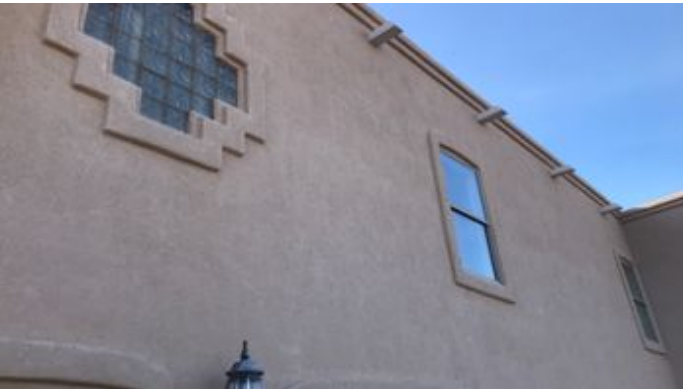
### 11.5 · FAILED SEAL

Observed condensation between the window panes, which indicates a failed seal. Recommend professional window contractor evaluate & repair as needed. Some of the other windows were also hard to operate or damaged. Showing signs of moisture damage at sills

Recommending repair

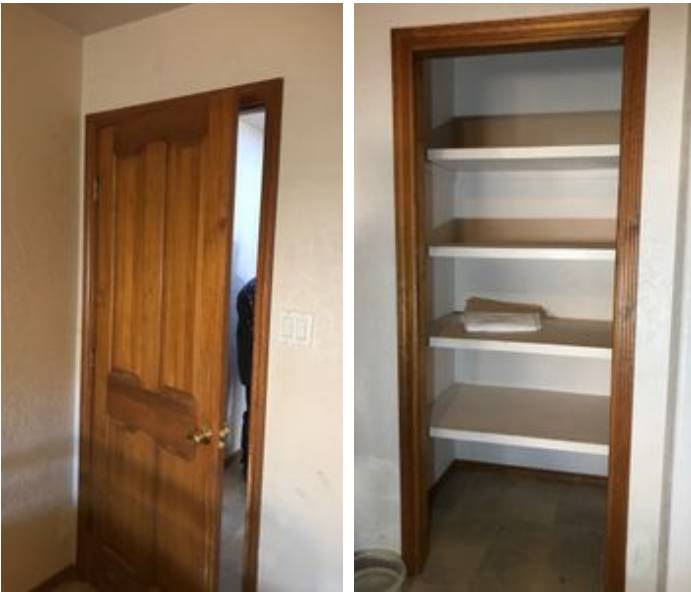
### 11.6 · INTERIOR DOORS

One or more doors were missing or did not latch properly, out of plumb. I recommend you have a professional door contractor repair.

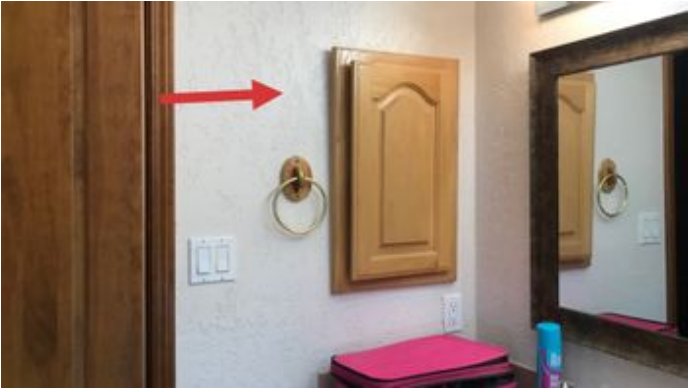
11.7 · SHELVES

Loose vanity in master bathroom. Recommending professional contractor fasten

Recommending repair

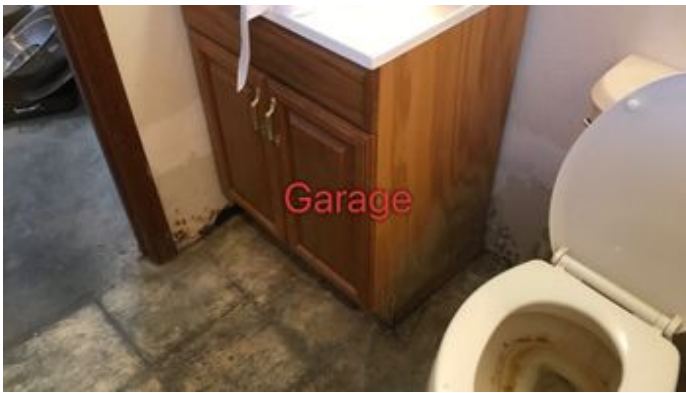
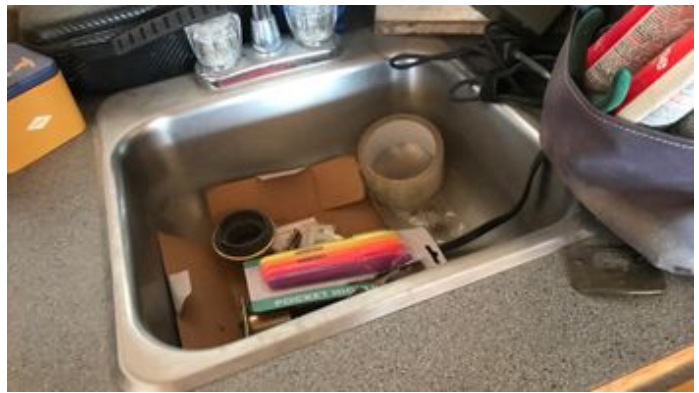
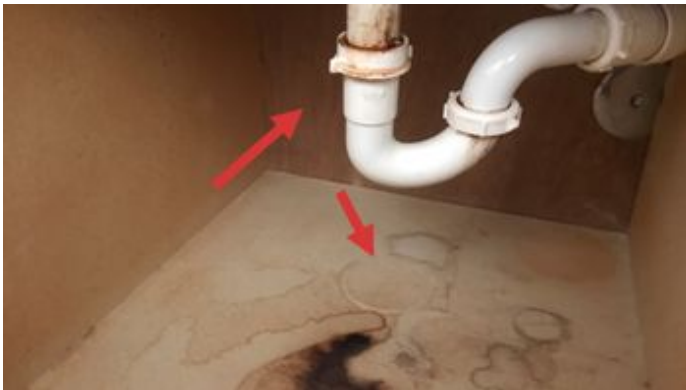
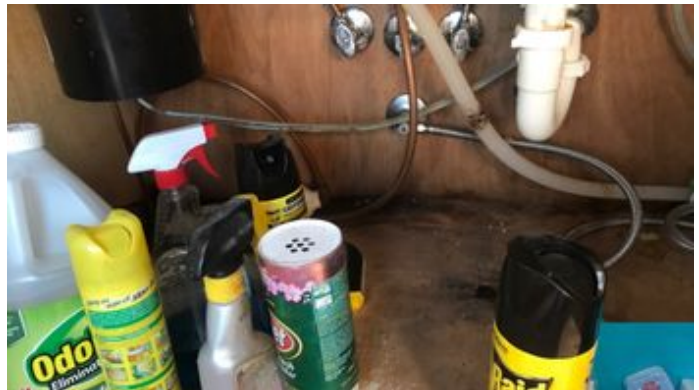
11.8 · SINKS

Multiple sinks / cabinets were in need of repair. Some showed signs of leaking, water damage, mold like substance. Sink in additional garage was not operational. I recommend you have a licensed plumber further review and repair.

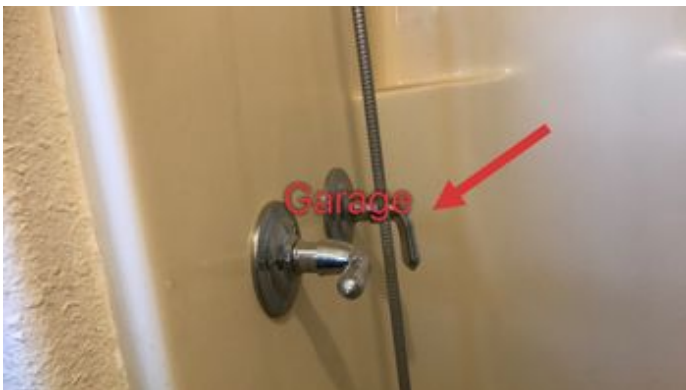
### 11.9 · FAUCET / SHOWER HEAD

During the inspection I could not get the cold water to work in additional garage shower. I tried it in various positions. It only had warm water. I recommend you have a licensed plumber evaluate and repair.

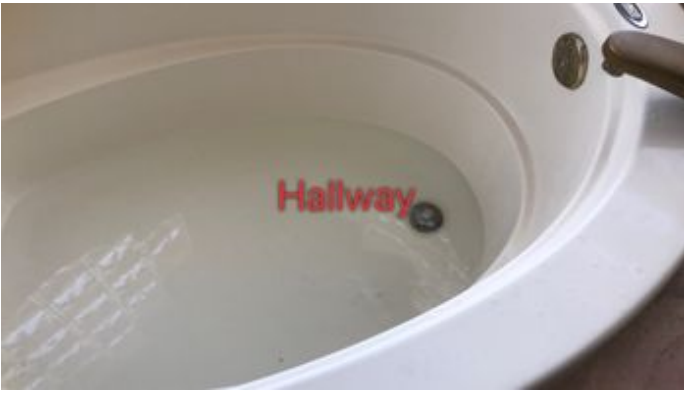
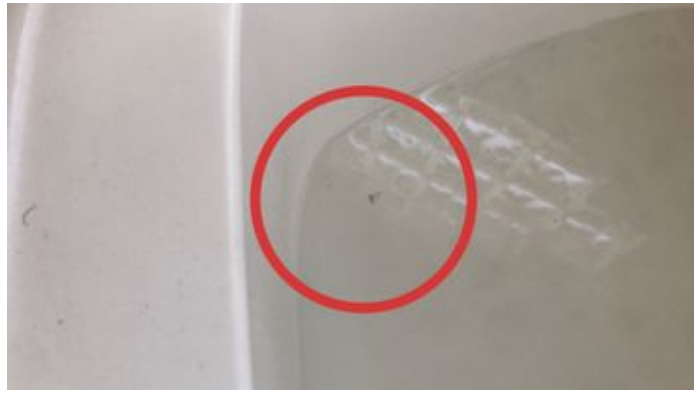
### 11.10 · PAN/TUB

Slow drain was observed during the inspection. This is located in hallway bathtub. This may be caused by a clogged p trap. The tub/shower surround was also damaged. I recommend you have this repaired by a licensed plumber.

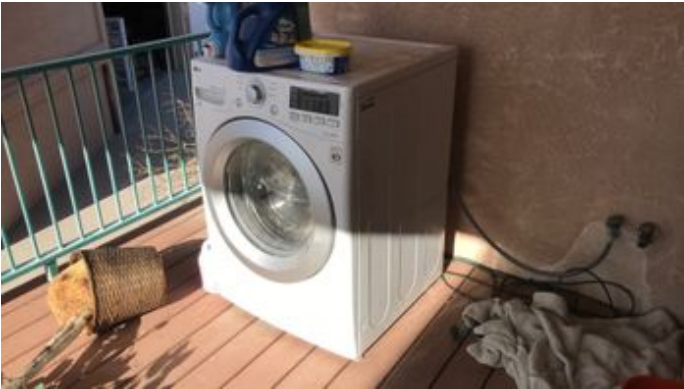
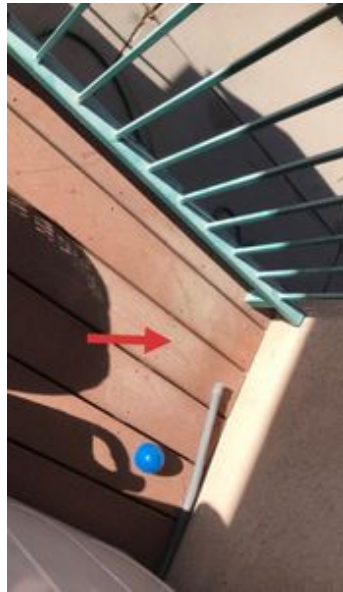
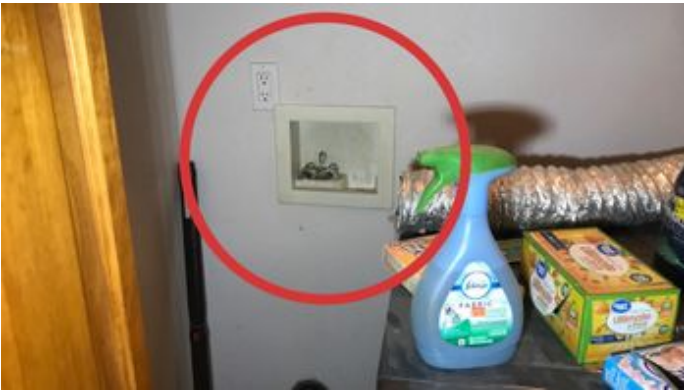
12.1 · WASHER/DRYER

Washer was installed in a substandard way at exterior of home. It's not clear why this was done since there are connections inside. This has been draining on deck and causing water damage to siding. Recommending repair by a professional contractor.

Recommending repair

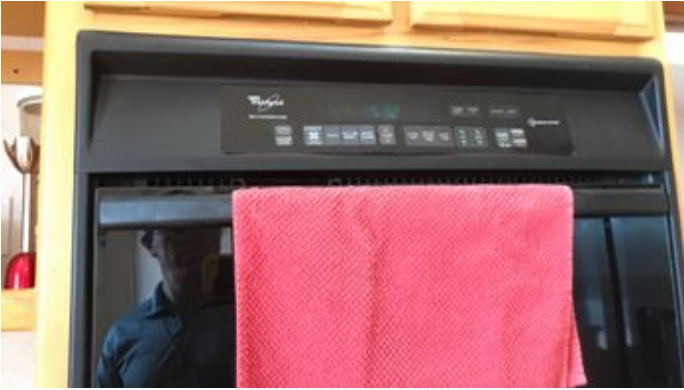
### 12.3 · OVEN

Oven button screen was damaged or peeling. Recommending repair by a professional appliance contractor

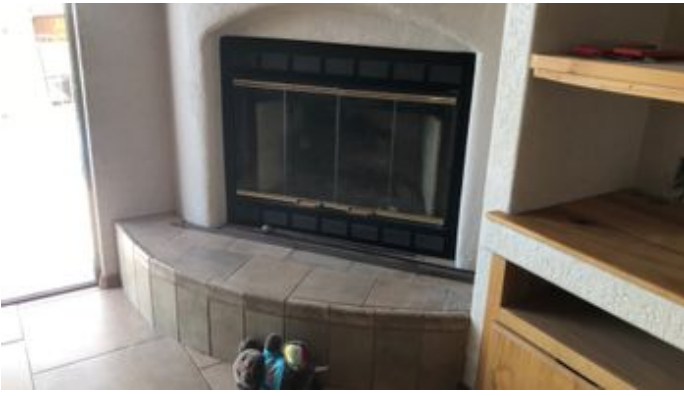
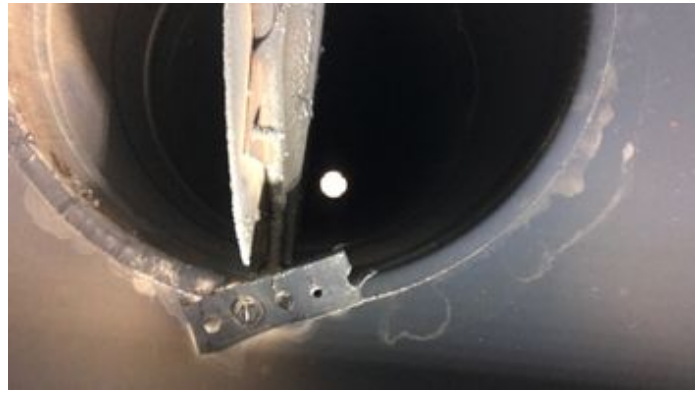
### 13.1 · TYPE

Gas fire place. This home features a gas burning stove. These are considered. Low efficiency. But it looks great. This is manual lighting stove home inspectors typically don't light these for liability reasons. I recommend you have a licensed plumber review for proper function. Or ask the current home owner.

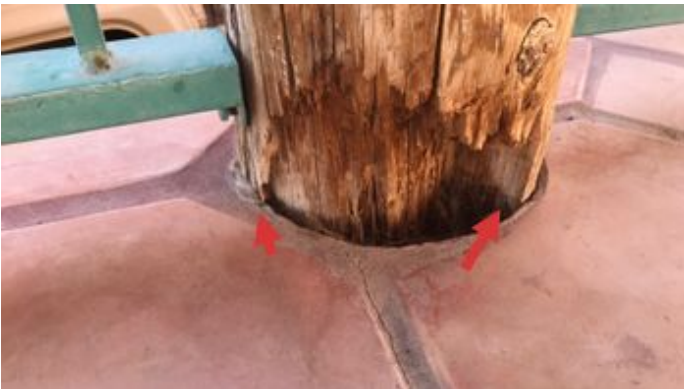
#### 14.1 · HOLLOWED OR DAMAGED WOOD

Port h support beam had signs of damaged wood from wood destroying organisms. It's recommended to have this further reviewed by a professional pest control service.

Further review is recommended
